# Two-Minute Inspection

pipetman®

pipetman®  
L

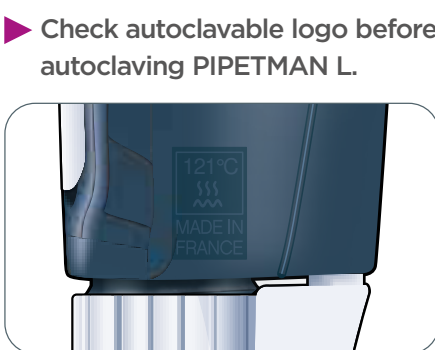
| A | A | 50001 |
| Year | Month | Production number |

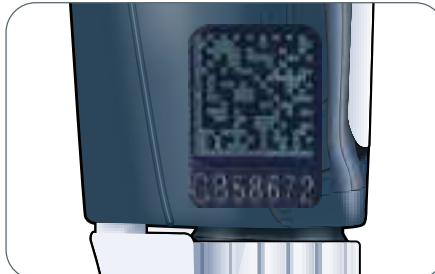
| A | A | 50001 |
| Year | Month | Production number |

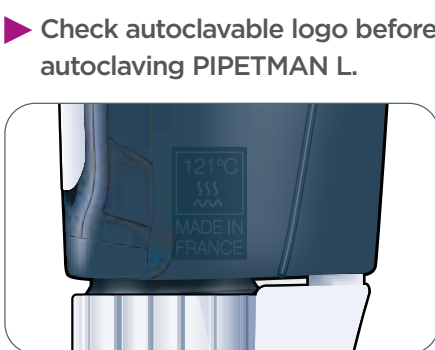
| A | A | 50001 |
| Year | Month | Production number |
